# 신규 모델 정보 및 품질개선 진행사항

엔진사업부  
2017/12/15

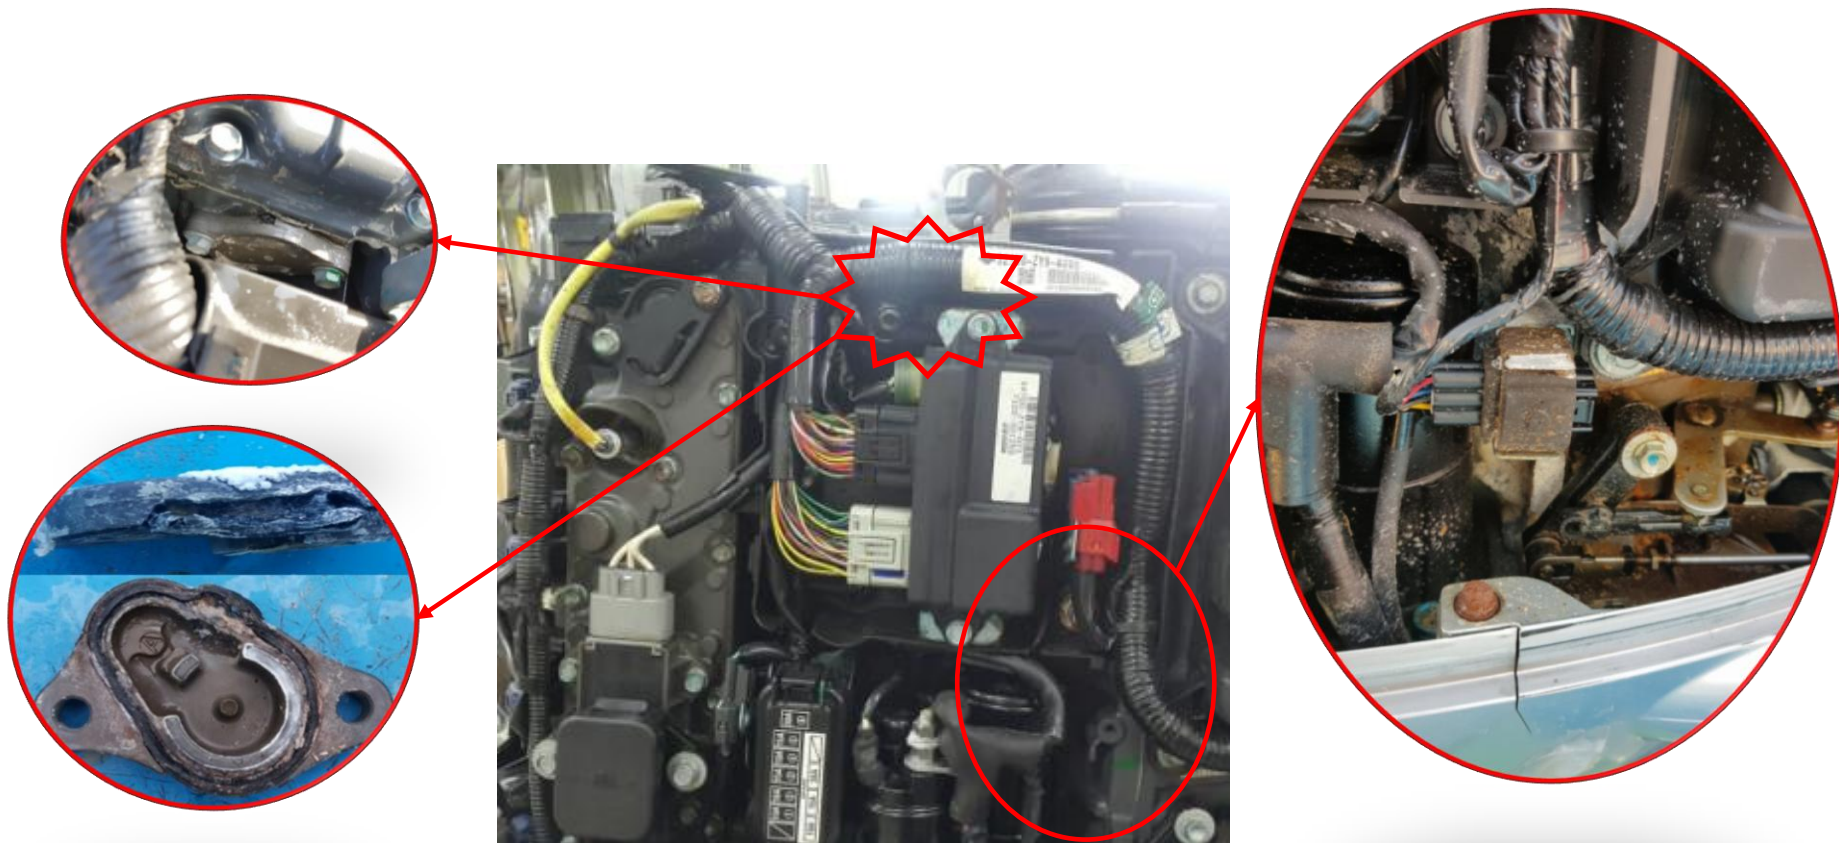
<90HP 서머스텝 커버 파손>

기존 타입의 경우 디자인상 블록의 서머스텝 교환이 어려움  
서머스텝 커버가 부식되어 깨지는 현상 발생.

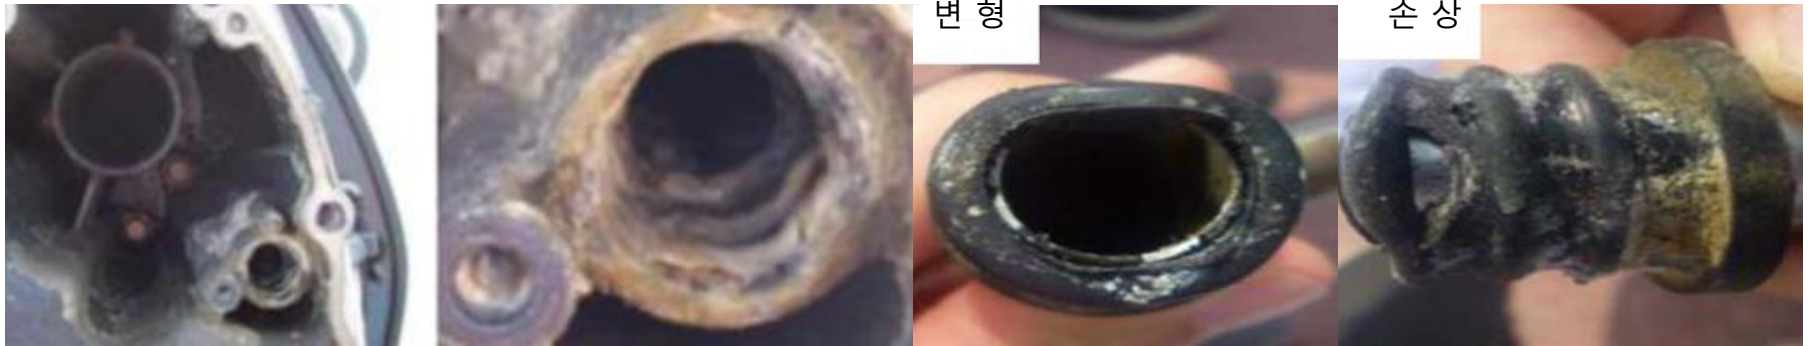
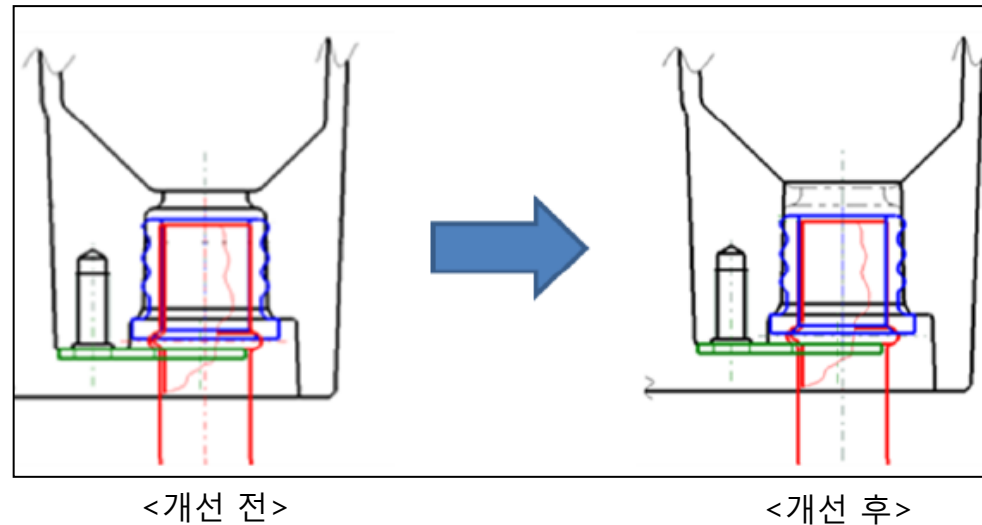
## ● 150마력 과열(워터 파이프 고무)

### • 150마력 과열(워터 파이프 고무손상)

- 5000RPM이상으로 일정 시간이상 운행시 엔진이 과열되는 현상.
- 오일의 부식및 워터파이프 고무의 손상을 막기 위해 오일팬의 디자인 개선
- 파트 번호:11321-ZY6-020ZB

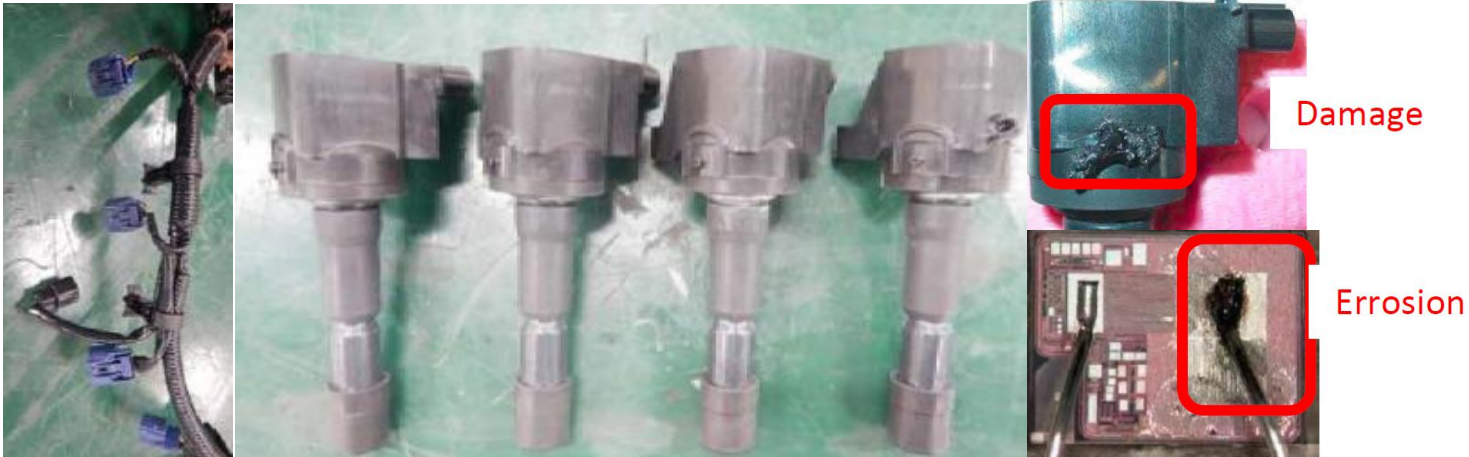
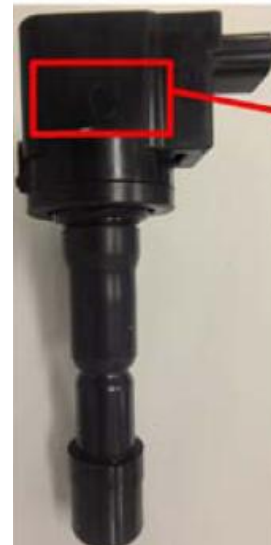
## ● 80~100HP 점화코일 불량

## • 80~100마력 점화코일 불량

- 엔진 1번 연소실 자리 코일의 손상
- 메인하니스의 커넥터와 코일 커넥터 사이에 수분이 들어가 그로인해 전기 단자의 손상
- 메인하니스의 커넥터와 코일 커넥터 사이에 그리스 도포 후 조립요망
- 파트번호: 30520-ZZ0-003

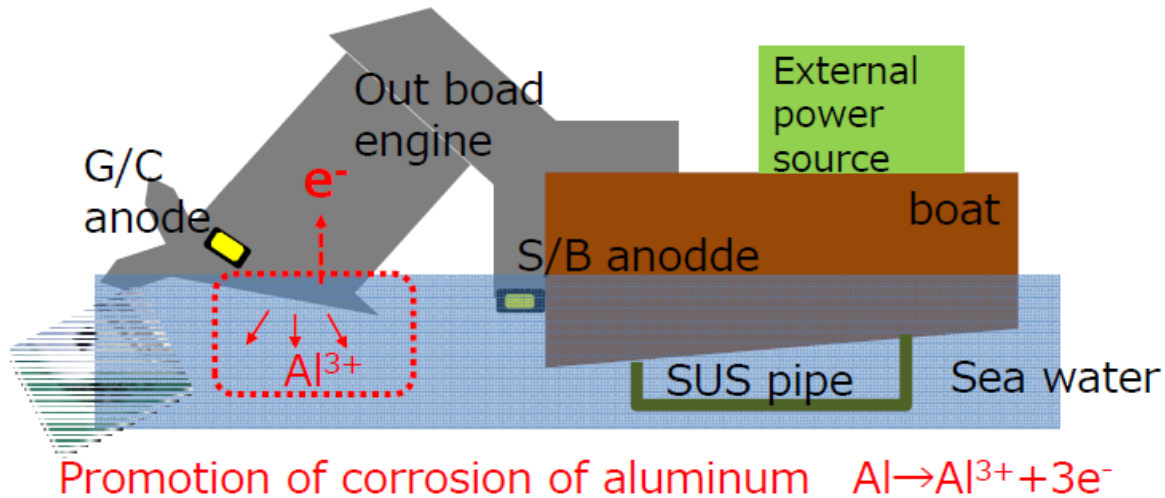
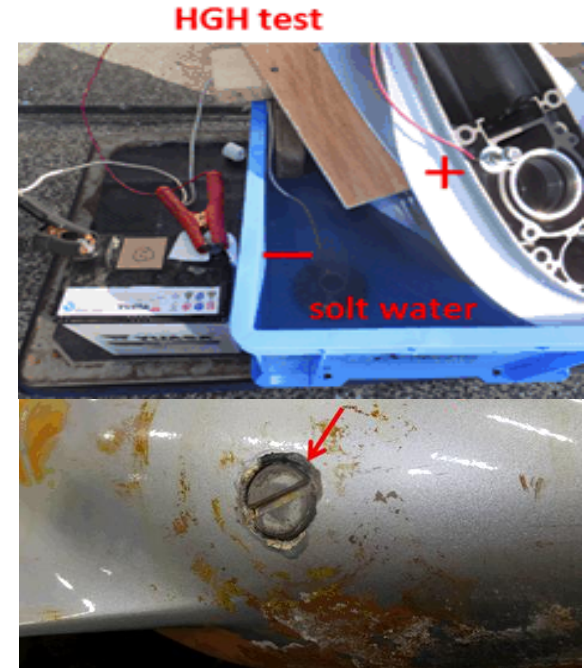
<전기 부식의 개념도>

### 부식원인

- 장착 환경(항상 기어케이스가 해수에 잠겨있는 경우)
- 전기통전으로 인한 전기적 부식 원인  
(엔진 배터리에 다른 전기장비의 전원선을 같이 사용)
- 보트 내 다른 금속물질이 장착되어있을 시(ex: 김양식의 금속 봉)

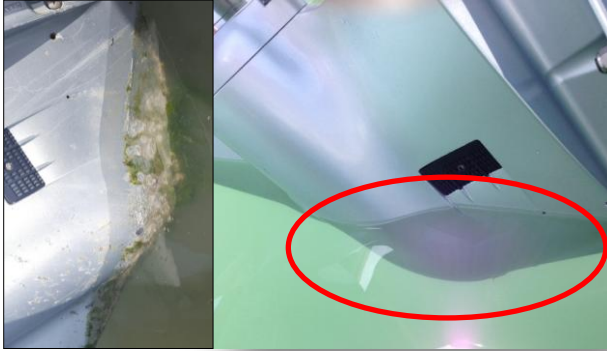
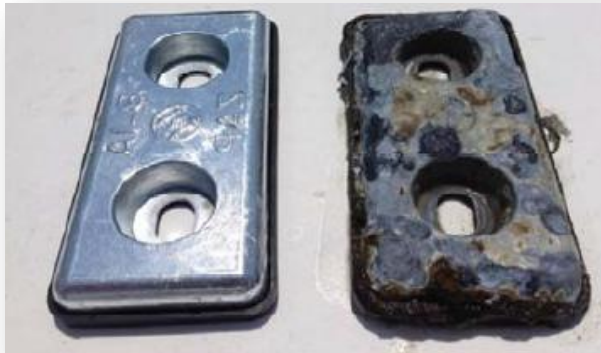
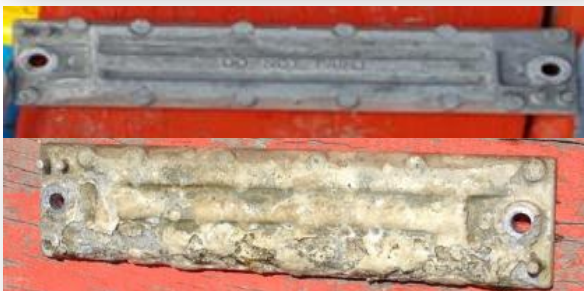
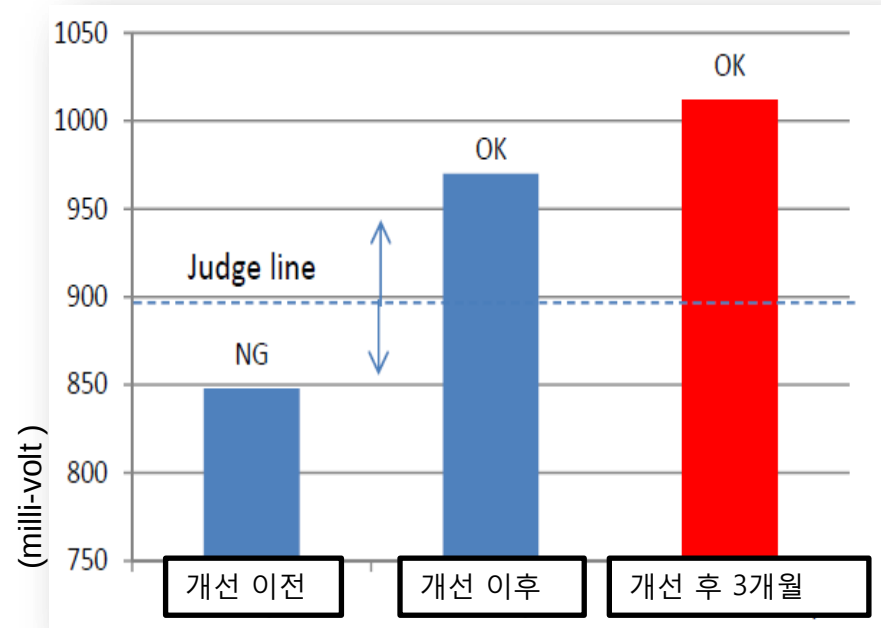
### ● 모니터링 결과

### 모니터링 확인 결과 (이상없음)

기어 케이스의 부식 보이지 않음

리드선 손상 없음

전압측정 결과 이상 없음

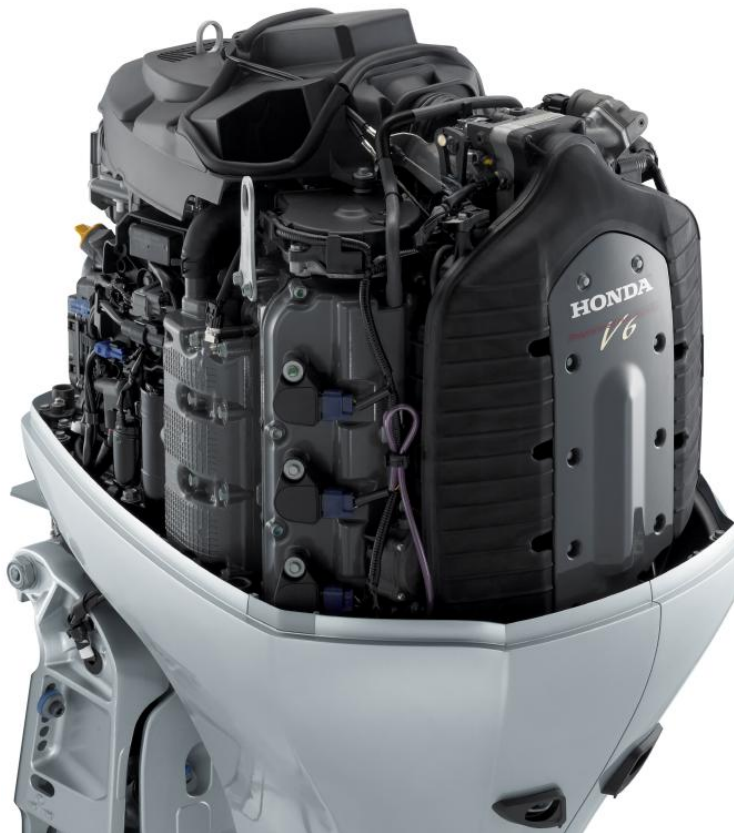
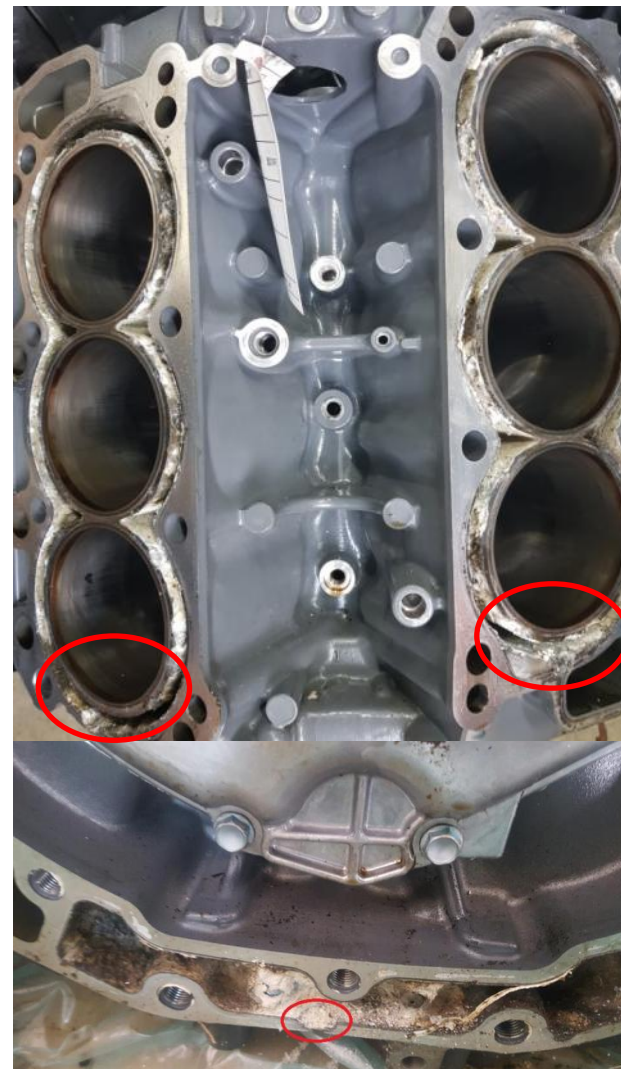
### ● 블록 부식 (냉각수 라인)

### 실린더 블록(냉각수 라인 부식)

- 블록내 아노드 메탈교환의 어려움(교환주기 1년 또는 200시간)
- 아노드 메탈 미 교환으로 인한 냉각수 라인 부식 발생

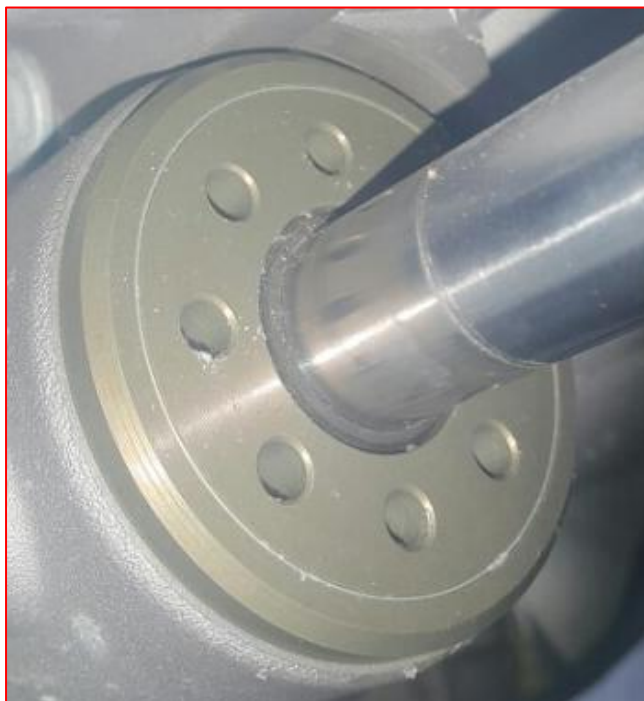
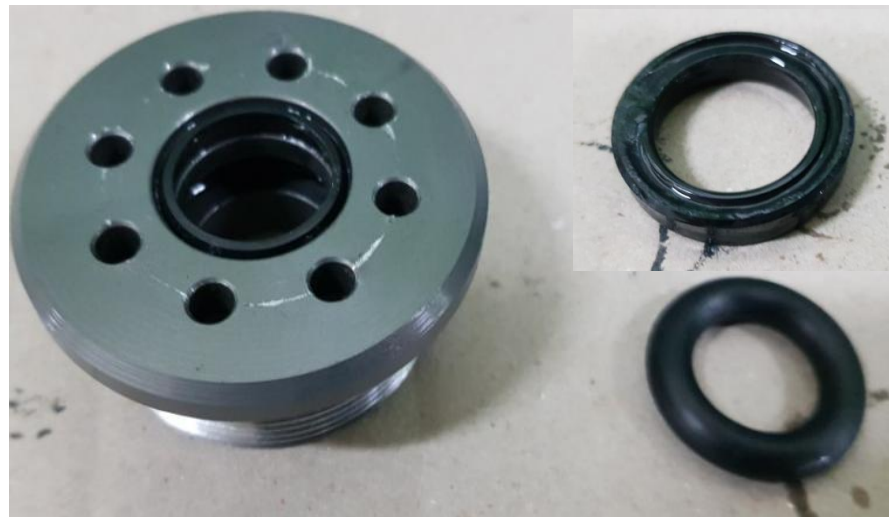
# ◆ BF90~250HP 파워트림 로드 가이드 누유 문제

## <원인>

로드 가이드 캡 마모로 인한 누유

## <개선>

로드 가이드 캡 품질 변경

56115-ZY9-013 GUIDE COMP., ROD

오일씰 빼고 O-Ring 사용
