| Model | Model Code | Model Type |
| BF115DK1 | BBHJ | |

Authorized by MATSUMURA HIROYUKI  
Power Product Service Engineering Department, Honda Motor Co.,Ltd

## Oil Leak From Engine Block

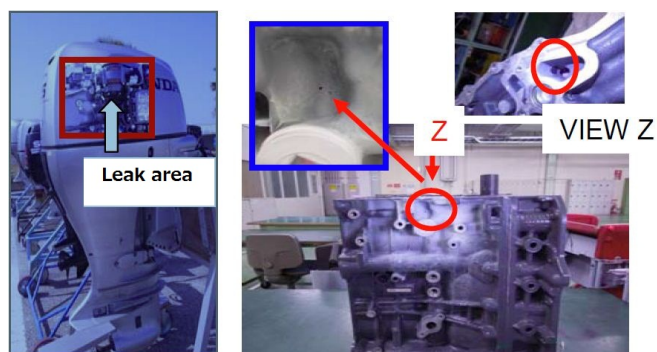
There is very small pin hole on cylinder block behind of ACG area. This pin hole pass through engine oil passage.

Cylinder block cut section

Factory repaired heat crack on cylinder casting die.

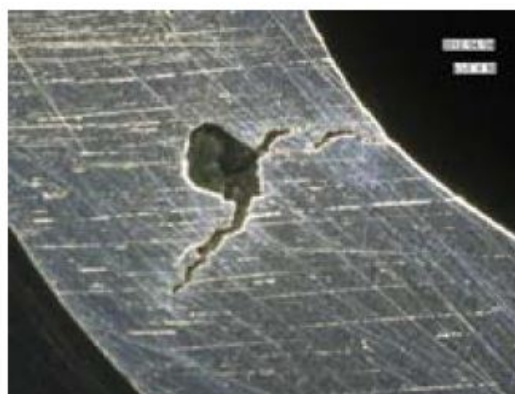
There is pin hole on cylinder block wall.

They found heat crack on cylinder casting die. Mold lubricant remained in heat crack then during casting process mold lubricant become gasification finally occurred pin hole on cylinder block.
