| Model | Model Code | Model Type |

Authorized by MATSUMURA HIROYUKI  
Power Product Service Engineering Department, Honda Motor Co.,Ltd

## Engine rpm did not increase

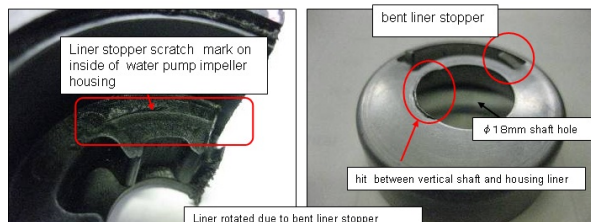
When install outboard engine on boat at DLR. During trial test engine rpm did not increase. Customer notice water flow is low from cooling water check hole.

During production process water pump liner did not install proper position in pump impeller housing assy. Water pump liner rotated in housing then clogged cooling water outlet port.

Fix as failed.

Please refer to shop manual.

Production process was modified.
