| Model | Model Code | Model Type |
| BF250A | BBJJ | |

## Salt Accumulation

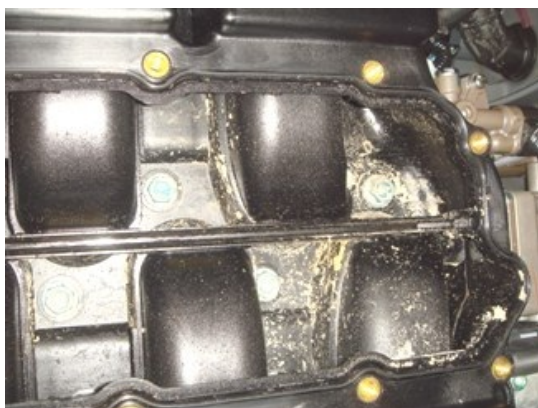
Salt accumulation on various engine parts and inside the engine air intake system.

Due to lack of water proof sealant on inner cover, Inner cover sealant did not perform then water leaked to inside of engine.

Please conduct engine appearance check during initial 20 hours or 100 hours regular service period at dealer. In case of there is any salt deposit or in case of customer is using outboard engine on heavy ocean waves area, please replace to C/M engine hood cover after cleaning the engine.

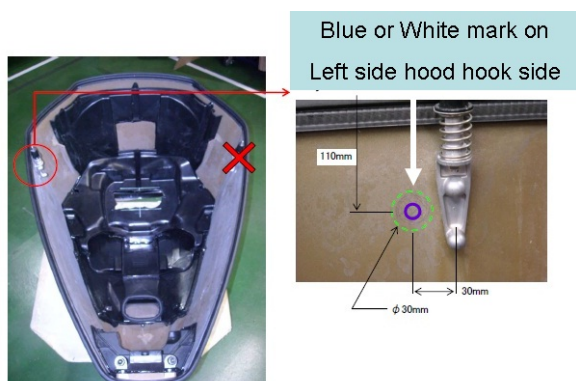
Countermeasure engine hood cover indicated paint mark as following area,
