| Model | Model Code | Model Type |
|---|---|---|
| BF250A | BBJJ | |

Authorized by MATSUMURA HIROYUKI  
Power Product Service Engineering Department, Honda Motor Co.,Ltd

## Salt Accumulation

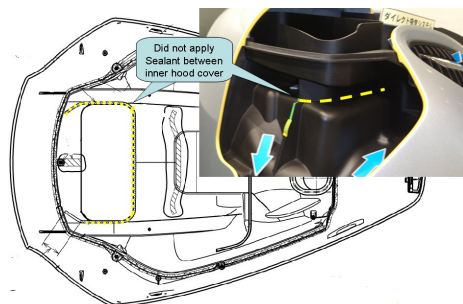
#### Countermeasure 1

Due to lack of water proof sealant on inner cover, Inner cover sealant did not perform then water leaked to inside of engine.

Apply sealant on inner hood cover.(factory forgot to apply sealant)

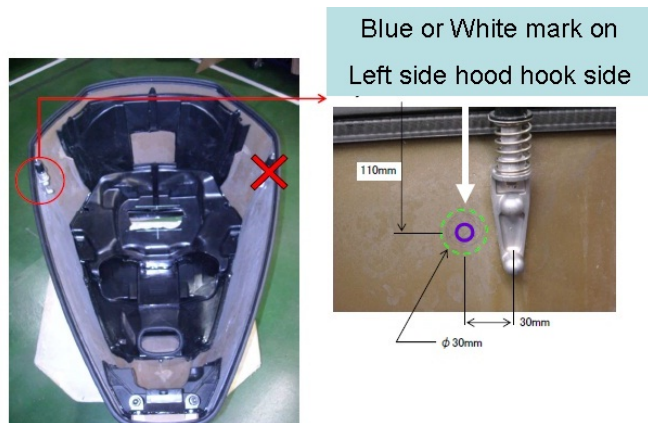
Countermeasure engine hood cover indicated paint mark as following area,

Replace with C/M engine hood cover after cleaning the engine.
