| Model | Model Code | Model Type |
| BF40DK2 | BBDJ | |
| BF50DK2 | BBEJ | |

## Low oil pressure at idle

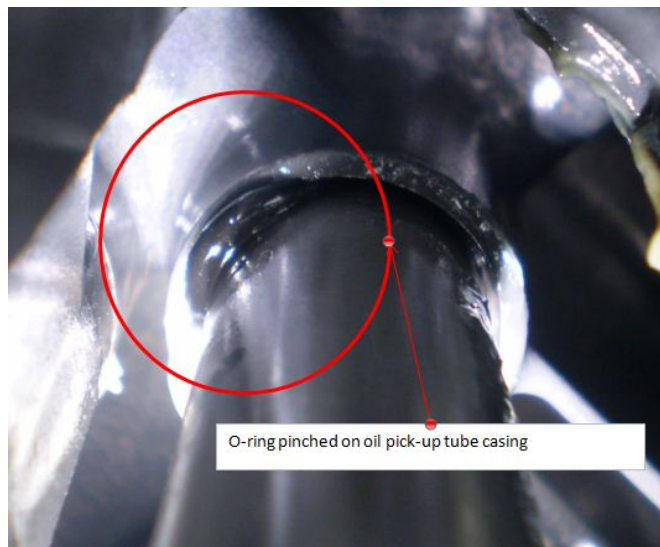
O ring of the oil strainer was stuck.

Operator inserted the strainer improperly at the production line.

And it caused the O ring pinched.

There are no instruction on operation standard.

1. Retraining the operator
2. Add the instruction of how to insert the strainer properly with picture to the operation standard.

1. Operator checked the O ring was not stuck by hand every unit.
2. If it is OK, operator marked at the oil pan packing.

Replace the O ring as per shop manual repair procedure.
