# 신규 모델 정보 및 품질개선 진행사항

엔진사업부  
2017/12/15

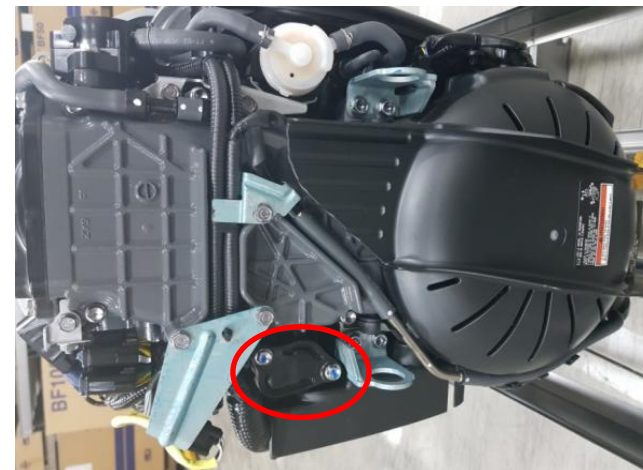
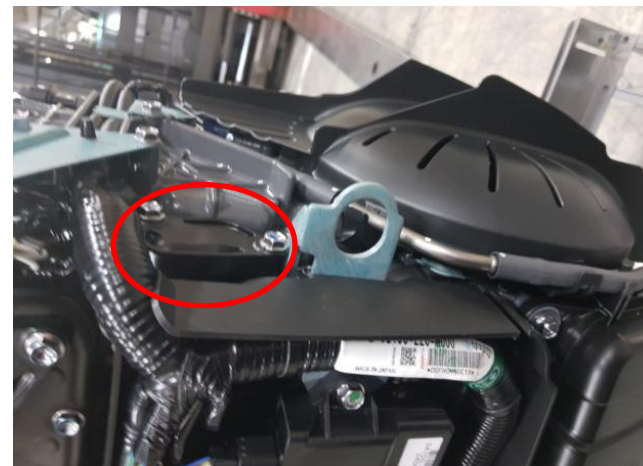
### •써머스탯 커버부분(써머스탯 장착위치 변경)

써머스탯 커버 :19315-ZY9 -H000 → 19315-ZW9 -0003

써머스탯 케이스: 19330-ZY9 -M000

케이스 패킹 :19331-ZY9 -M000

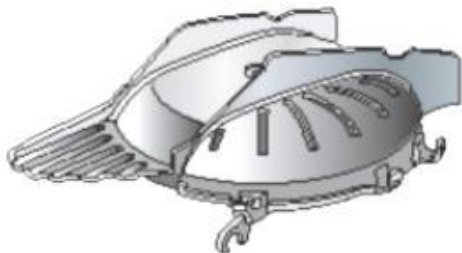
### •발전기 커버

변경된 발전기 커버의 핀 부분은 엔진커버로 물이 새지 않도록 변경.

재질 P.P + talc

31145-ZY9 -0001 → 31145-ZY9 -M000

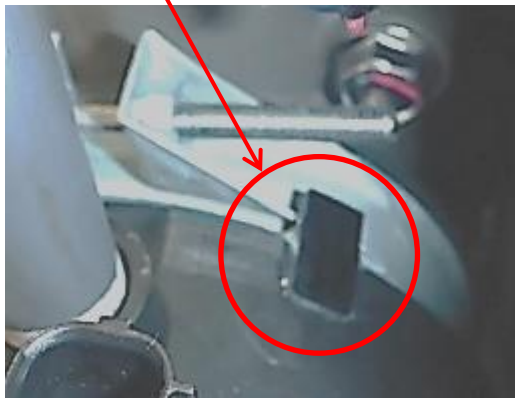
- 공기유입구

고정 밴드 돌출부 위치 변경

17201-ZZ5 -0101 → 17200-ZZ5 -M000

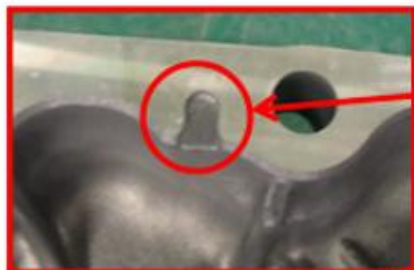
11410-ZY9-415ZA

Groove addition

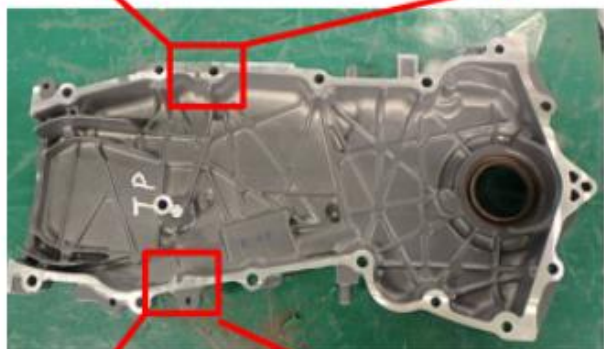
Groove addition

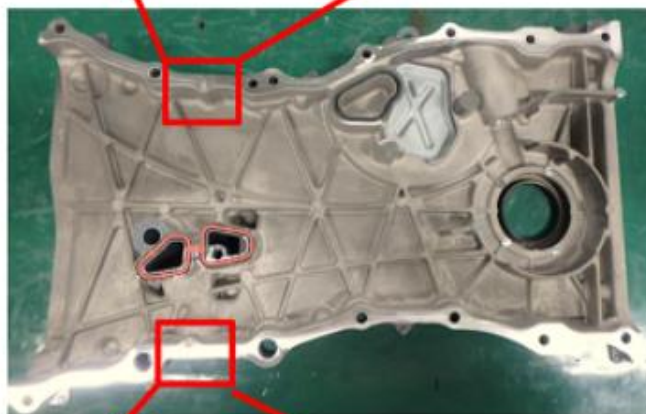
11410-ZY6-435ZA

Groove addition

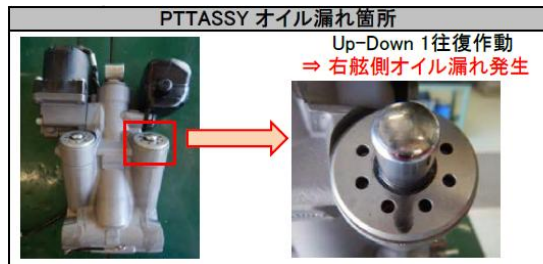
# ◆ BF90~250HP 파워트림 로드 가이드 누유 문제

## <원인>

로드 가이드 캡 마모로 인한 누유
